Cost and Performance Report

Pit 6 Landfill Operable Unit

Lawrence Livermore National Laboratory Site 300

UCRL-AR-128480

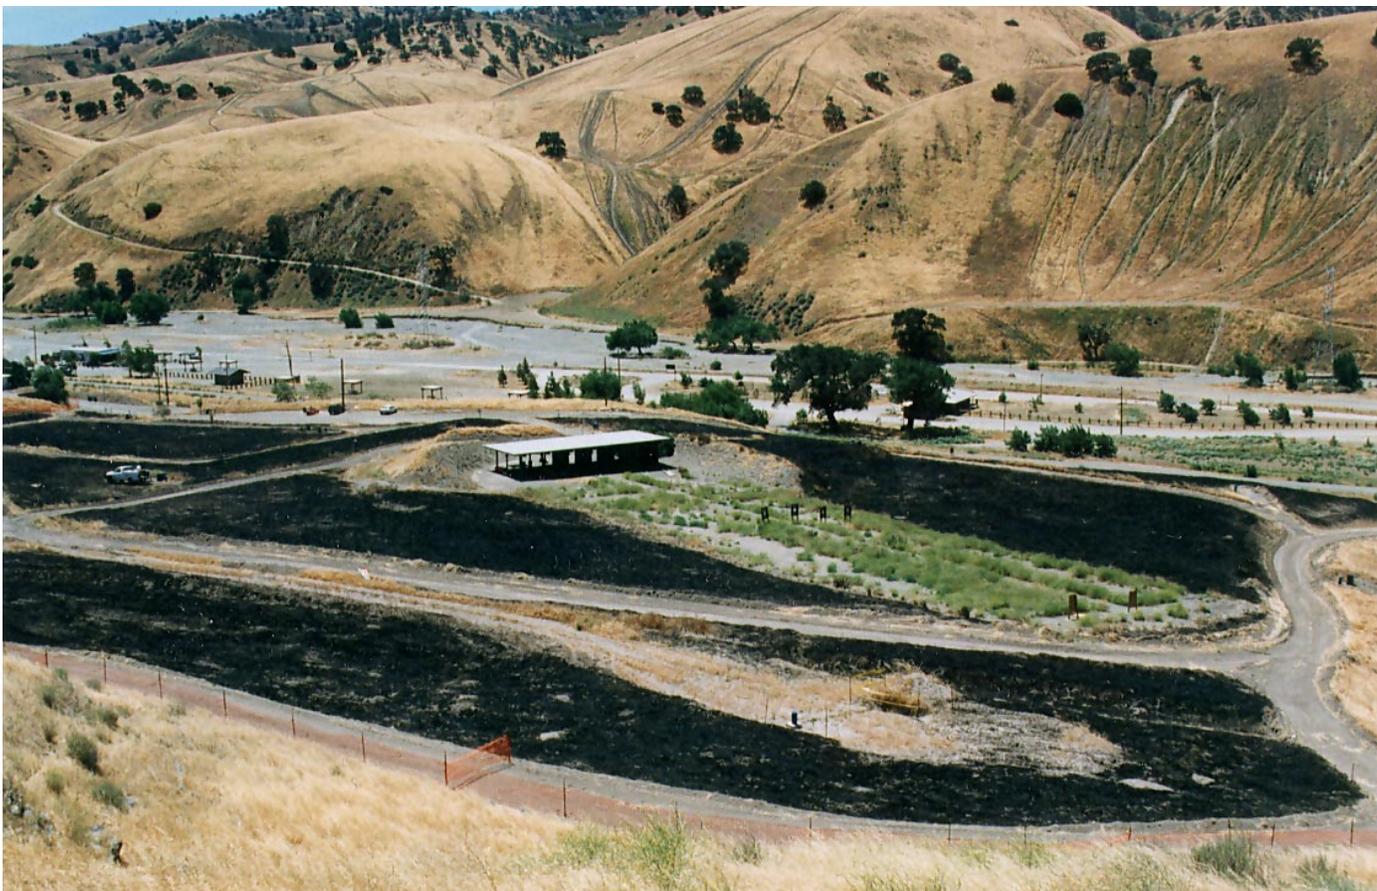
Pit 6 Landfill and overlying rifle range prior to cap construction; view looking south (May 1997).

After burial, all waste was covered with several feet of native soil. The landfill was not constructed with liners, containment structures, or leachate control systems. Due to safety considerations, no intrusive investigations of the buried material have been performed. A rifle range used for training exercises by LLNL was located directly over the landfill.

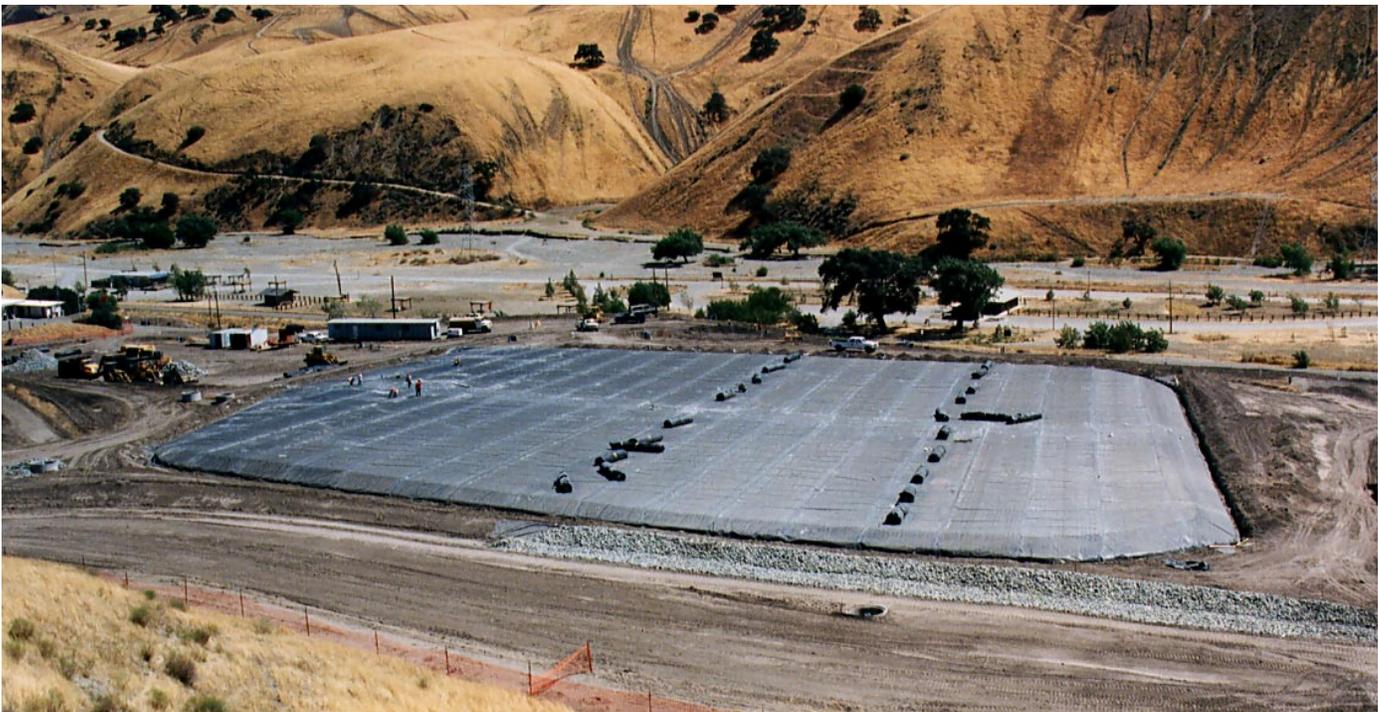
Pit 6 Landfill liner during installation; view looking south (July 1997).

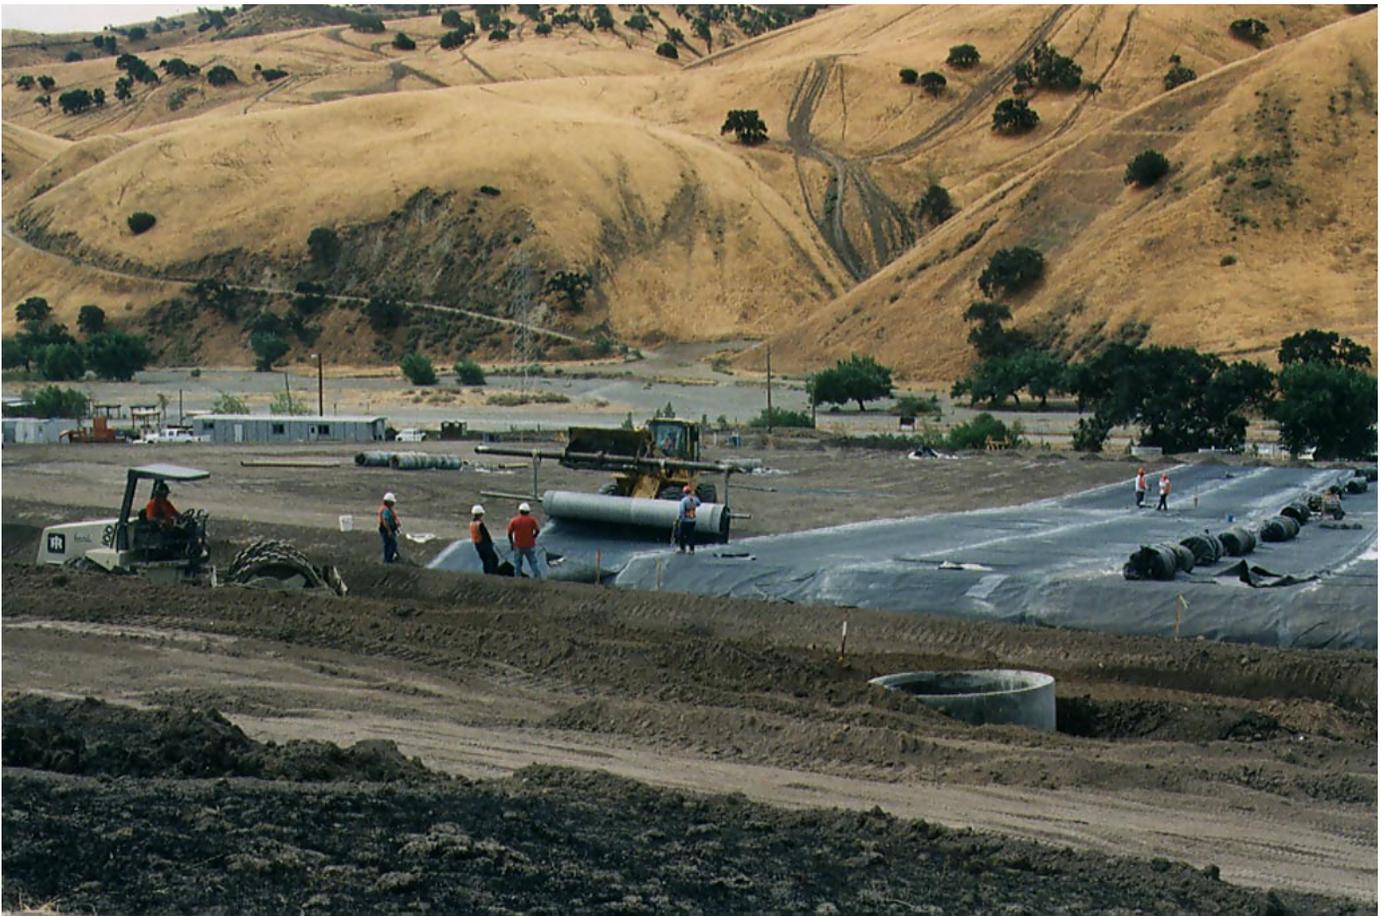
Installing the HDPE/geosynthetic clay liner (July 1997).

Selectively substituting geosynthetic materials for natural materials saved over \$500,000. Using a HDPE/geosynthetic clay liner in place of one to two feet of clay virtually eliminated concerns over possible desiccation cracks, low moisture content, and compaction of the impermeable liner during hot weather construction. Additionally, installation was much faster and quality assurance was more controllable.
